In Search of Safer Skies

A Report on Aviation Safety

Toya Dahal
2065 B.S.

Society of Ex-Budhanilkantha Students (SEBS)

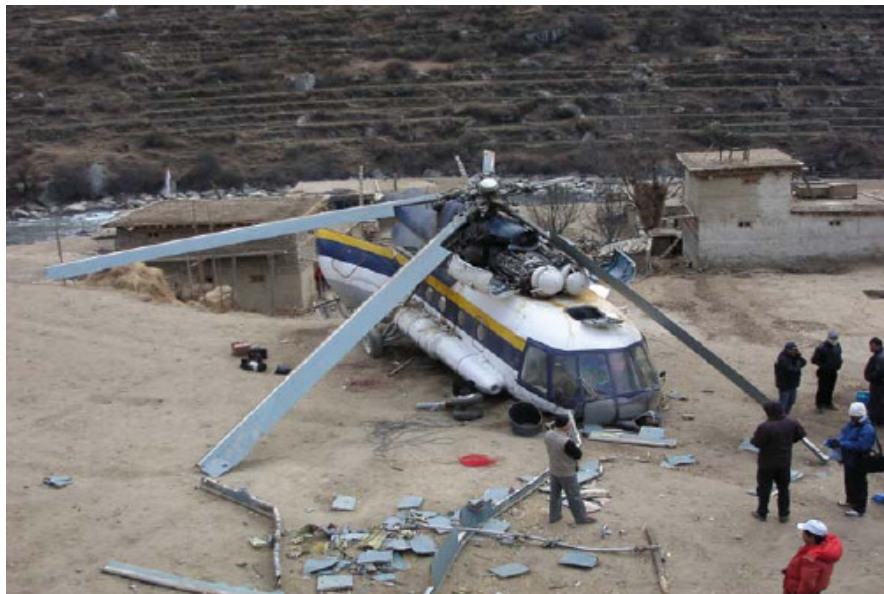
The Commission determines the probable cause of the helicopter 9N-ADO accident at Raralihi as the failure of the Captain to positively identify the intended landing site pointed out by the co-pilot. Additionally, lack of the Captain's familiarity with the unmarked and dirtcovered landing site located in the terrain of Raralihi, too restricted to allow Mi-8 MTV-1 helicopter landing, led to the accident.

Wreckage of helicopter 9N-ADO at Raralihi, Jumla
